SUBJECT: **MBE 4000 Block-to-Cylinder Head Joint Repair Information**

MBE 4000 Cylinder Head to Block Joint Repair Information

Leak Diagnosis, Cylinder Head and Block Repair

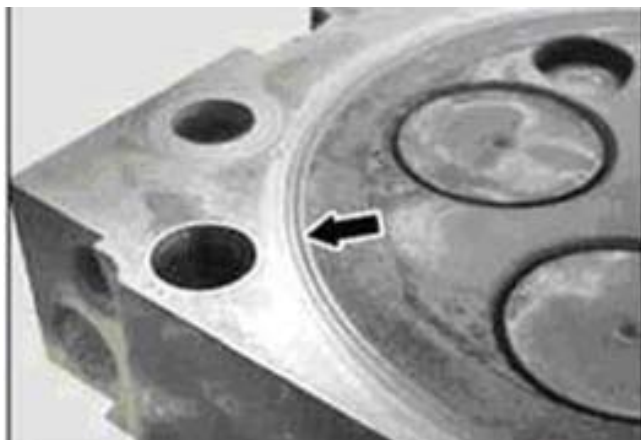
There are three types of fire decks: 1) a very old flat fire deck with no heat treat in the combustion seal area and no recess in the coolant and oil grommet area – see Figure 9, 2) a heat treated original equipment fire deck cylinder head with flat grommet sealing areas, and 3) a heat treated original equipment fire deck cylinder head with recessed grommet sealing areas - see Figure 10. This style has four crescent shaped raised sections around the combustion seal. These raised areas are done by design and should not be confused or misunderstood for deck warping.

Figure 9. Cylinder head with no recess around oil and coolant grommet areas

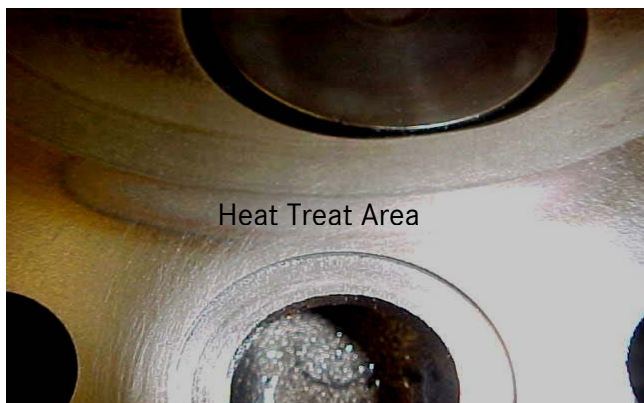
Figure 10. Head with heat treated combustion area and recessed grommet area

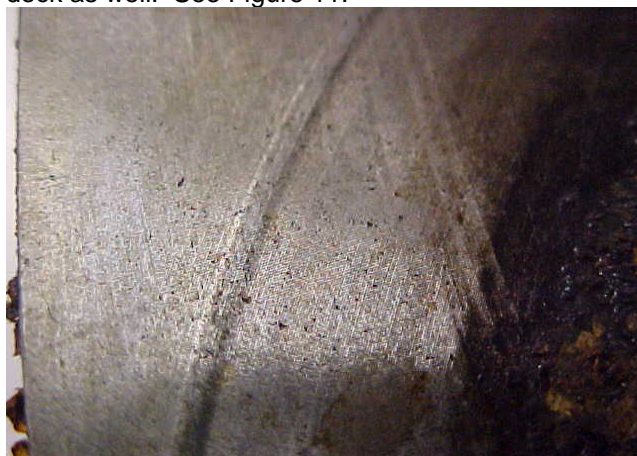
The remanufactured cylinder head has a raised bead ring around the combustion seal surface area. There will be a gap if a straight edge is placed over this deck as well. See Figure 11.

Figure 11. Raised section of combustion sealing area

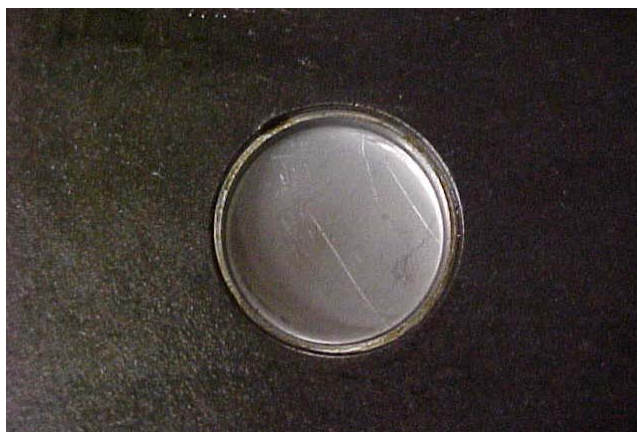
There are also heads with two cup plugs and heads with one cup plug and one solid plug. See Figure 12 and Figure 13.

Figure 12. Cylinder head with cup plug

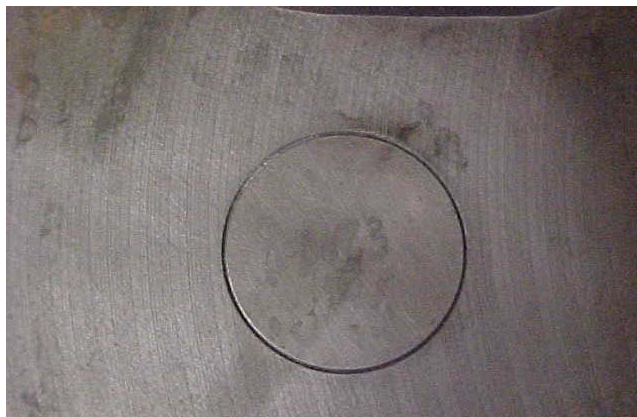
Figure 13. Cylinder head with solid plug

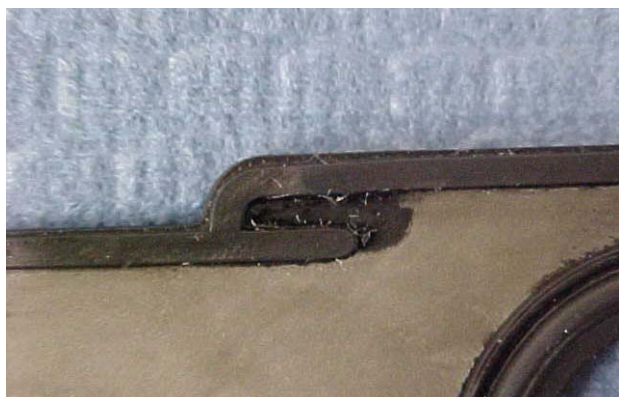
Four different head gaskets have been used over the last several years: 1) flat grommet without vent, 2) flat grommet with vent, 3) raised grommet without vent, and 4) raised grommet with vent. The last design that is recommended to be used is the closed vent gasket that matches the flat or recessed grommet hole in the cylinder head. Figure 14 shows the closed vent gasket, Figure 15 shows the open vent head gasket, while Figure 16 shows the flat grommet and Figure 17 shows the raised grommet.

Figure 14. Closed vent head gasket

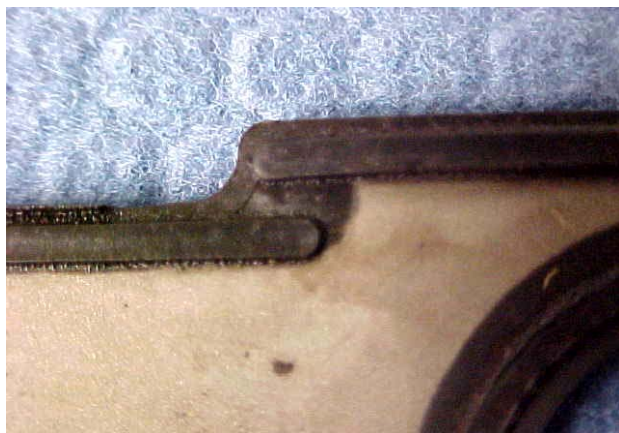
Figure 15. Open vent head gasket

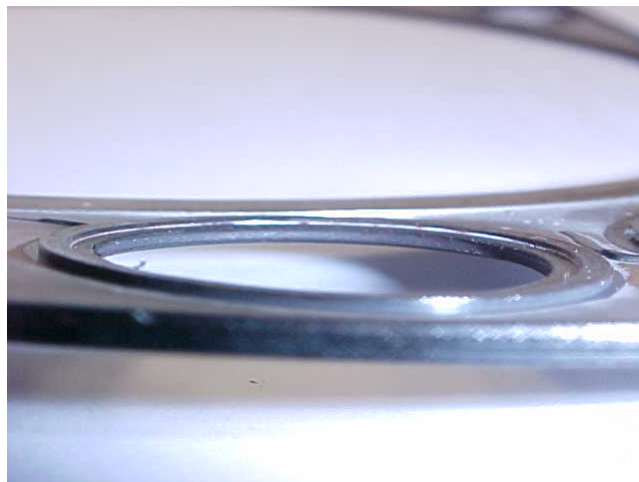
Figure 16. Gasket with flat grommet

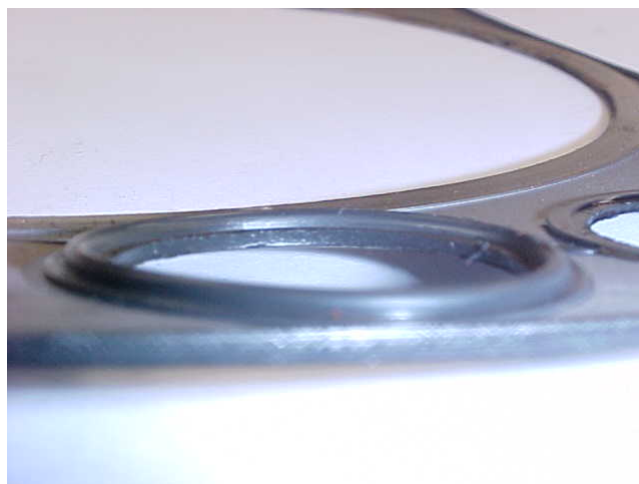
Figure 17. Gasket with raised grommet

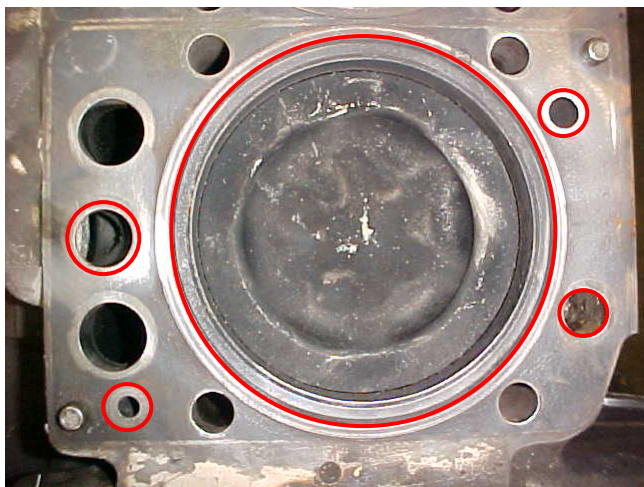
The sealing areas are: 1) the compression seal around the liner, 2) the two coolant holes that are sealed with grommets, and 3) the two oil holes that are sealed with grommets. See Figure 18.

Figure 18. Critical head sealing areas

These five areas are the most important to maintain and qualify to ensure a quality repair. The liner height is set by the counterbore cut and sets the proper crush for sealing the combustion chamber as well as the other grommets. For high mileage units, the recommendation is to set the liner heights to the lower half of the specification, this will allow for minor surface imperfection while applying maximum crush on the grommets. Reference [08 TS-8Rev](#).

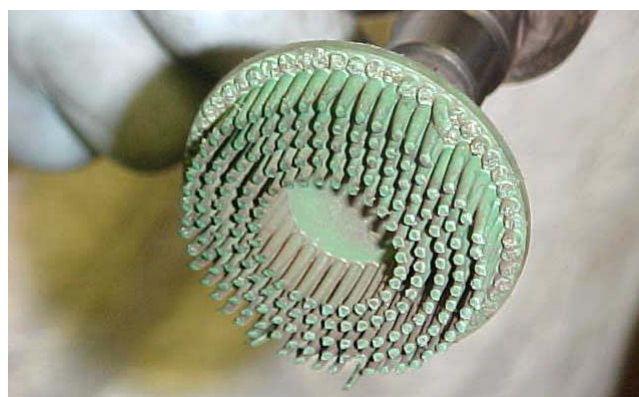
Figure 20. 3M Roloc Bristle Disc 2", used for cleaning mating surfaces

3M Roloc Bristle Discs are recommended to remove carbon and surface rust. These discs come in three levels of abrasiveness: green (50 grit), yellow (80 grit), and white (120 grit) for different purposes. See Figure 20.
